Country Club Hills, IL RLR 3 Year Follow-Up

Evaluation Report

Reference No: 016-47399 May 2022

Re: RLR 3 Year Follow-Up Evaluation Report 175th St and Cicero Ave (Northbound) City of Country Club Hills Ref #: 016 --47399

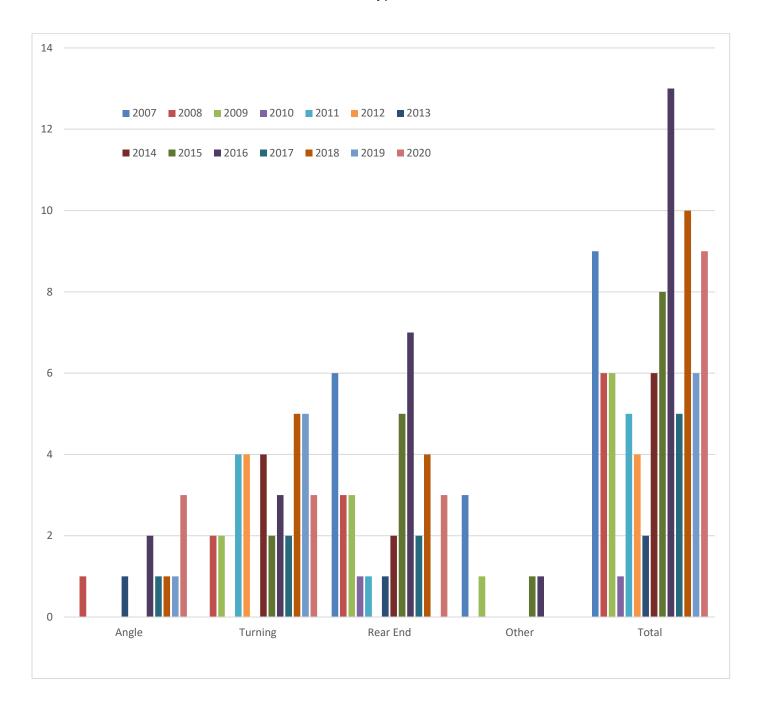
The Chart below shows the trend of each crash type from 2007-2020.

Type Year	Angle	Turning	Rear End	Other*	Total	Yearly Average
_	2007	0	0	6	3	9	
Before Installation	2008	1	2	3	0	6	7
motuliation	2009	0	2	3	1	6	
	2010	0	0	1	0	1	
	2011	0	4	1	0	5	
	2012	0	4	0	0	4	
	2013	1	0	1	0	2	
	2014	0	4	2	0	6	
After	2015	0	2	5	1	8	6.9
Installation	2016	2	3	7	1	13	6.8
	2017	1	2	2	0	5	
	2018	1	5	4	0	10	
	2019	1	5	0	0	6	
	2020	3	3	3	0	9

* Other crashes include: Sideswipe and Other/Fixed Object.

From 2007-2009, prior to RLR camera installation, there were 21 total crashes; this averages out to 7 crashes a year.

From 2011-2020, post RLR camera installation, there were 68 total crashes; this averages out to 6.8 crashes per year - a 2.86% reduction of overall crashes in direct comparison with the time period aforementioned.

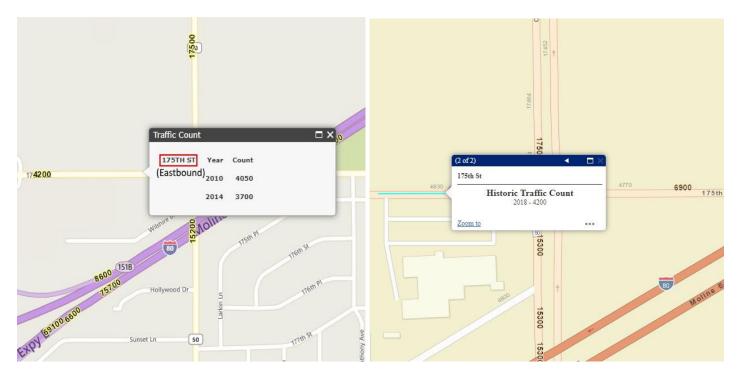
Eastbound ADTC

175th St ADTC

- Eastbound: 4,300
- Westbound: 8,900

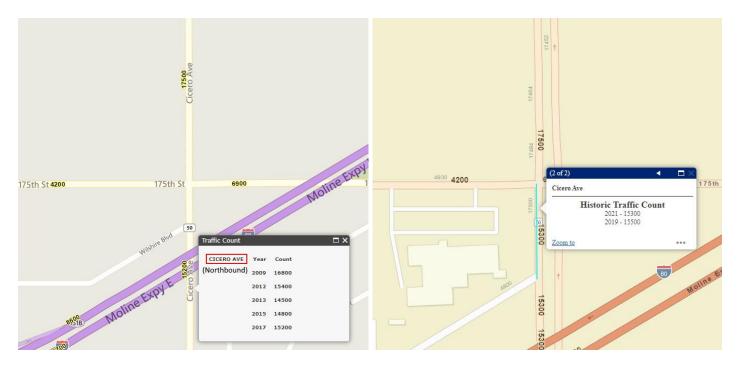
Northbound ADTC

Cicero Ave (IL Route 50) ADTC

- Northbound: 18,800
- Southbound: 19,200
