183rd St and Pulaski Rd

Country Club Hills, IL RLR Follow-Up Evaluation Report

Reference No: 016-45014

April 2024

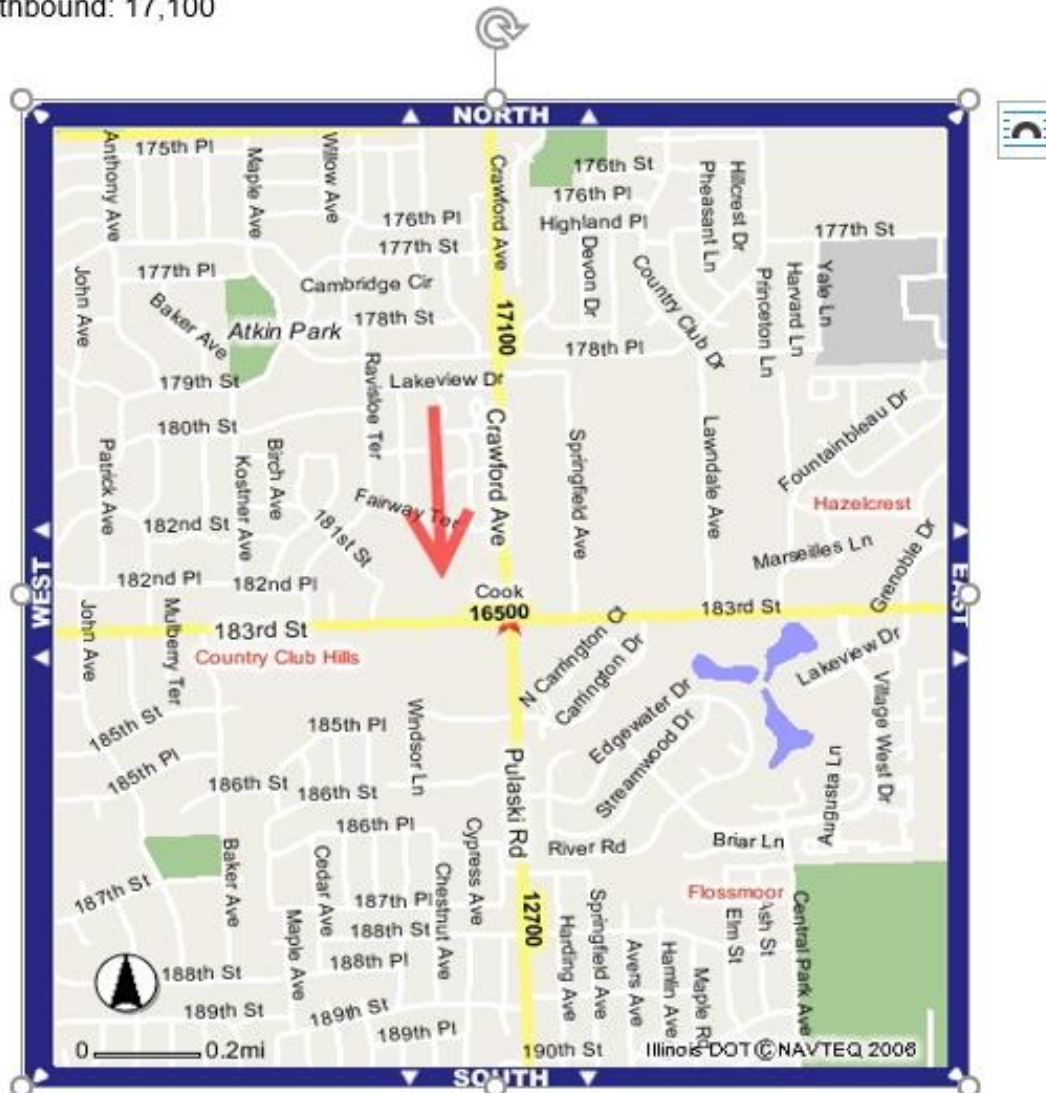
2008

183rd St ADTC

- Eastbound: 16,500
- Westbound: 16,500

Pulaski Rd (Crawford Ave) ADTC

- Northbound: 12,700
- Southbound: 17,100
